RBI accelerator facility and the earthquake (and the corona)

Milko Jakšić et al, Ruđer Bošković Institute, Zagreb, Croatia

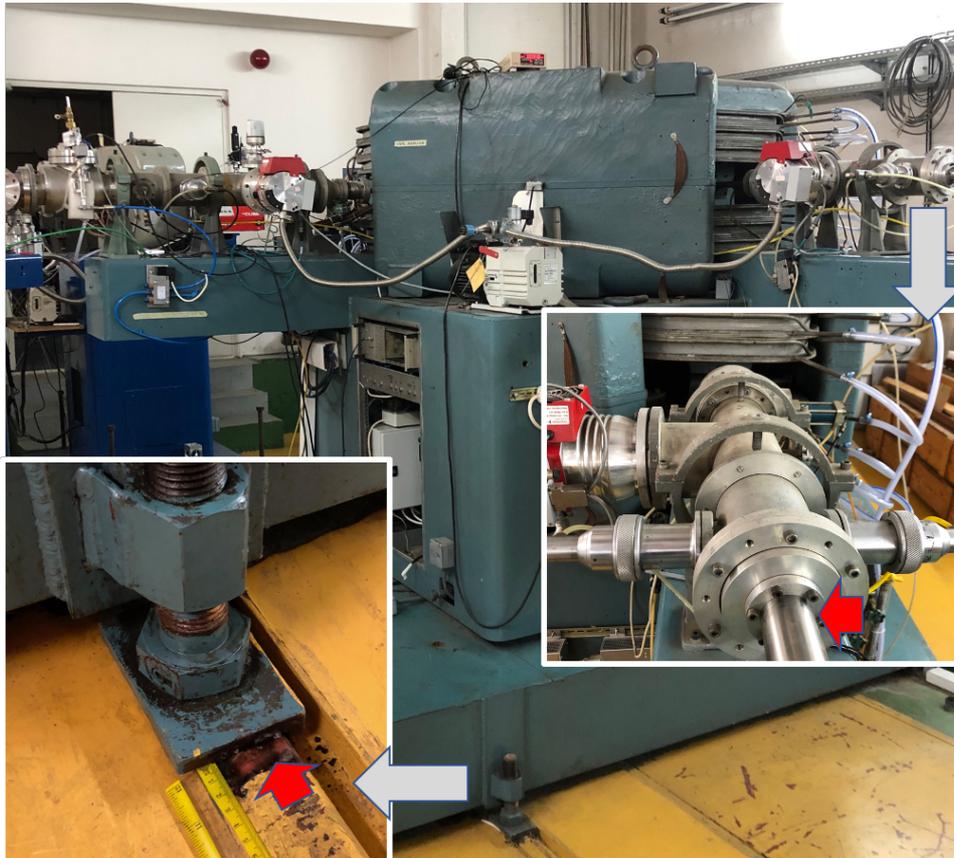
Opening of the vacuum tubes around these two magnets showed immediately that the beam direction from the analyser magnet to the switching magnet was translated by at least 2 cm towards north. We still did not have a clue why this happened, until we noticed that the entire support of the 90 degree magnet (6 tons) has been shifted towards the north by these 2 cm !!

Surprisingly, the fact that the distance between the accelerator and analyser magnet has been increased by 2 cm, did not influence the vacuum was quite interesting. The solution of this puzzle could be explained by the way connection between the vacuum tube and slits before the magnet has been realized. The seal surface happens to be outside of the 2 inch tube which can be (by a strong force – which earthquake obviously was) pulled out or pushed in. Some traces of this action are even noticeable at the above pictures.

Fortunately, after we realized that the whole 90 degree magnet has been displaced, we needed less than an hour to realign it back to its original position.

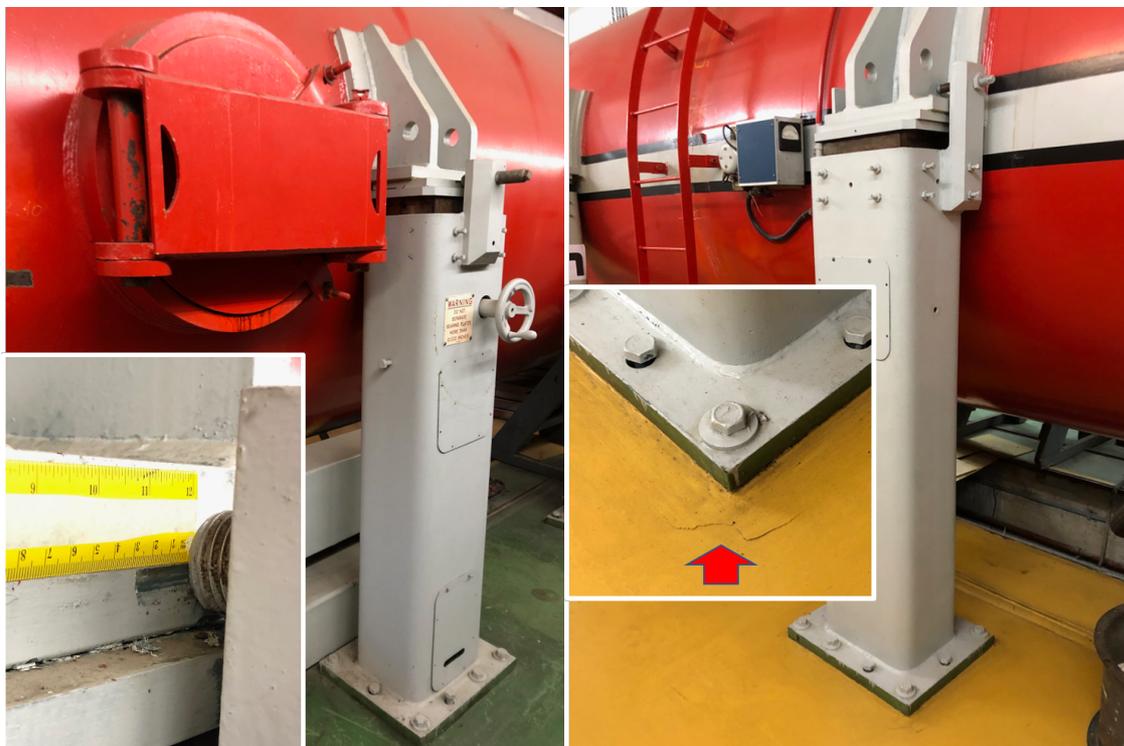
But, all these findings, gave us a hint to check if the accelerator tank itself has been moved as well. And it was not a big surprise to find that it actually did. Fortunately (again), the tank was only shaking and probably stabilised after the earthquake at its original position. The tank is supported by total of 8 legs and each of those have noticeable traces of these movements. The most visible one is shown below, where tightening screw at the plates that hold the tank at the support legs made a scratch of 30 mm. Most of these support plates have been sliding during the earthquake which can be noticed by pieces of paint that has been rubbed away. However, at some of the support legs this connection was strong enough and no traces of movements were found up there. For these legs, we have noticed cracks down in the floor.
