RBI accelerator facility and the earthquake (and the corona)

Milko Jakšić et al, Ruđer Bošković Institute, Zagreb, Croatia

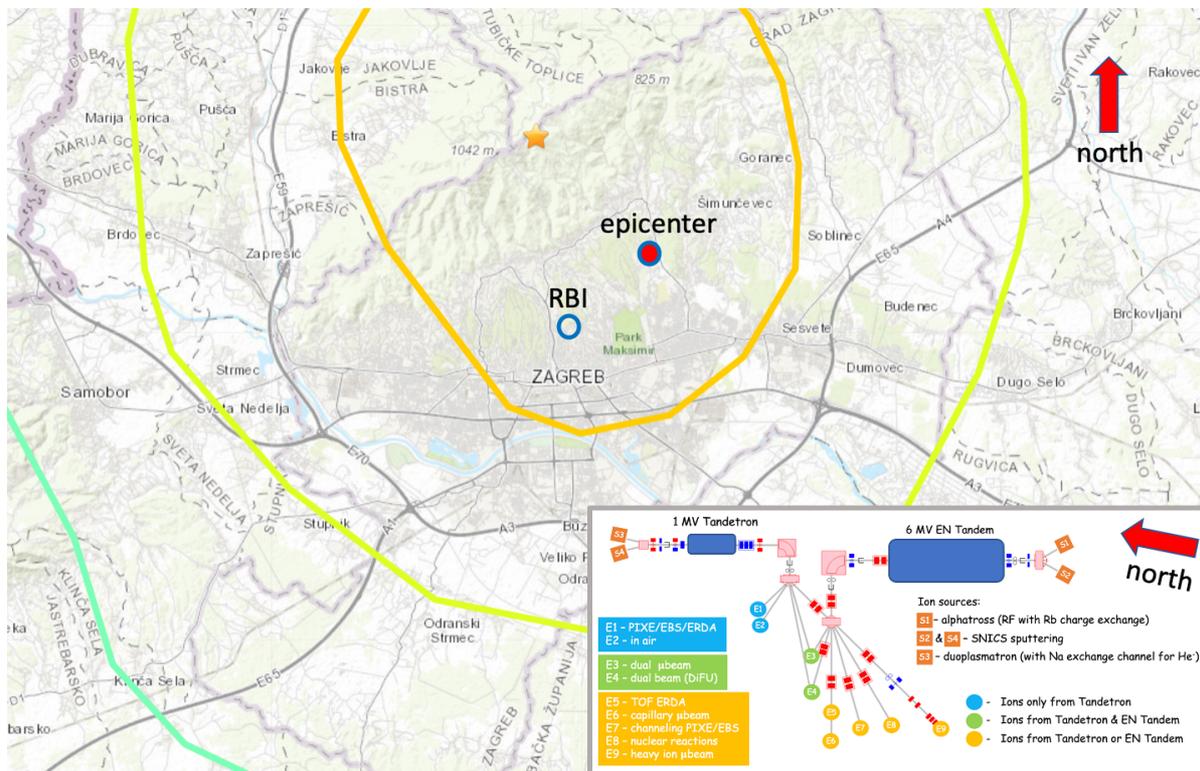
On Sunday the 22nd of March, at 6:22 in the morning, an earthquake of 5.5 magnitude hit the city of Zagreb and its surroundings. Its epicentre was 10 km underground and approximately 10 km northeast of the RBI campus and its accelerator facility. Orientation of both of the tandem accelerators is close to the north-south direction. An earthquake happened just 3 days after the RBI accelerator facility has been closed due to the corona crisis. All electronics and the vacuum system have been shut down as well.

Few hours after the earthquake, as well as in several other occasions that followed, staff of the lab checked visually for possible damages and confirmed that apart from some relatively small cracks in the walls that did not influence the statics of the building, no other facility components were damaged.
